Report on the investigation of
the fatality on board
passenger cruise ship

Saga Rose

in Southampton, England

Report No 01/2009
January 2009

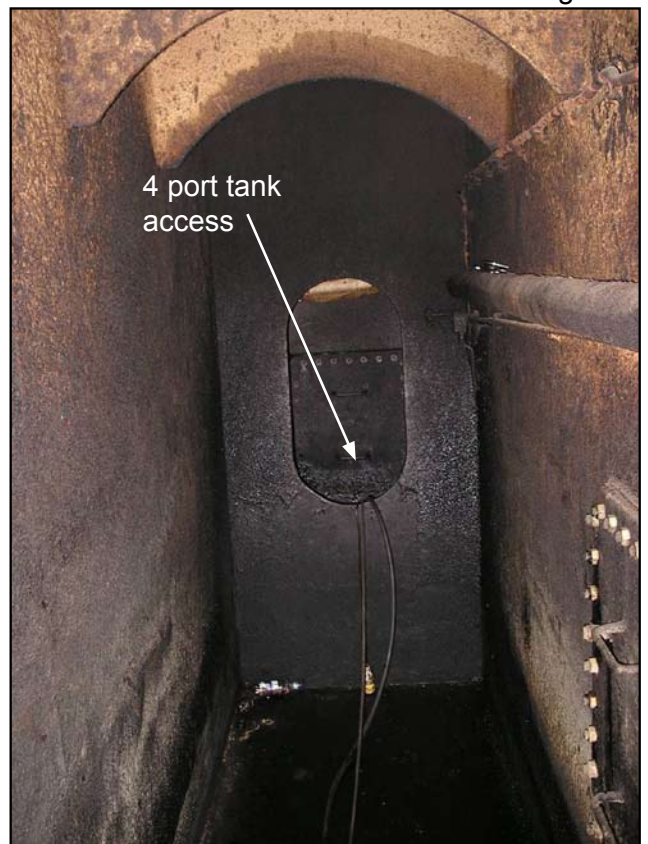
Figure 5

Cofferdam with tank access

The manhole was at the far end of a 5 metre open cofferdam (**Figure 5**) which was accessed through a lightening hole from the purifier room (**Figures 3 and 4**). The cofferdam was situated between two heated fuel oil service tanks and

the temperature in the cofferdam was between 40° and 50°C. Illumination was provided by a light with a wandering lead, and, other than for access to the double bottom tank, this space was not normally entered.
